## ARCHITECTURAL RESOURCES: DESCRIPTION AND EVALUATION

### Bellvue Farmstead (N-3975)

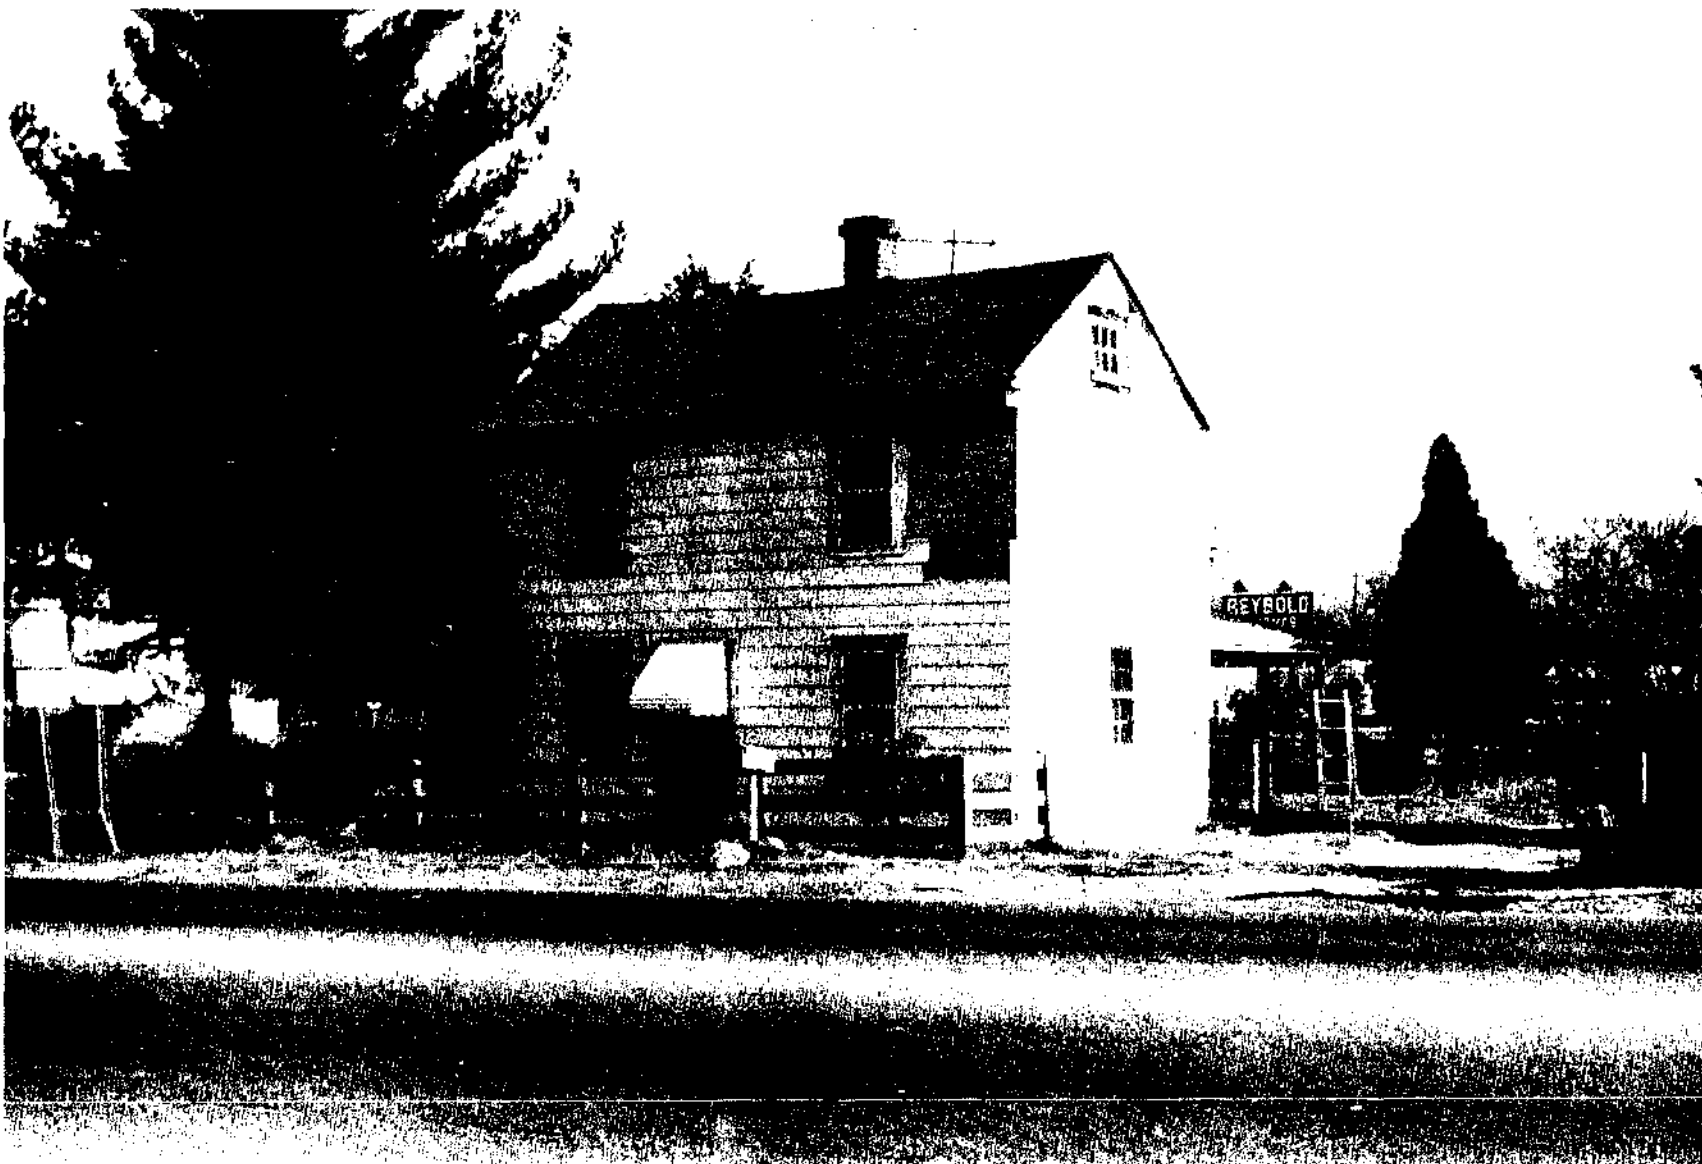
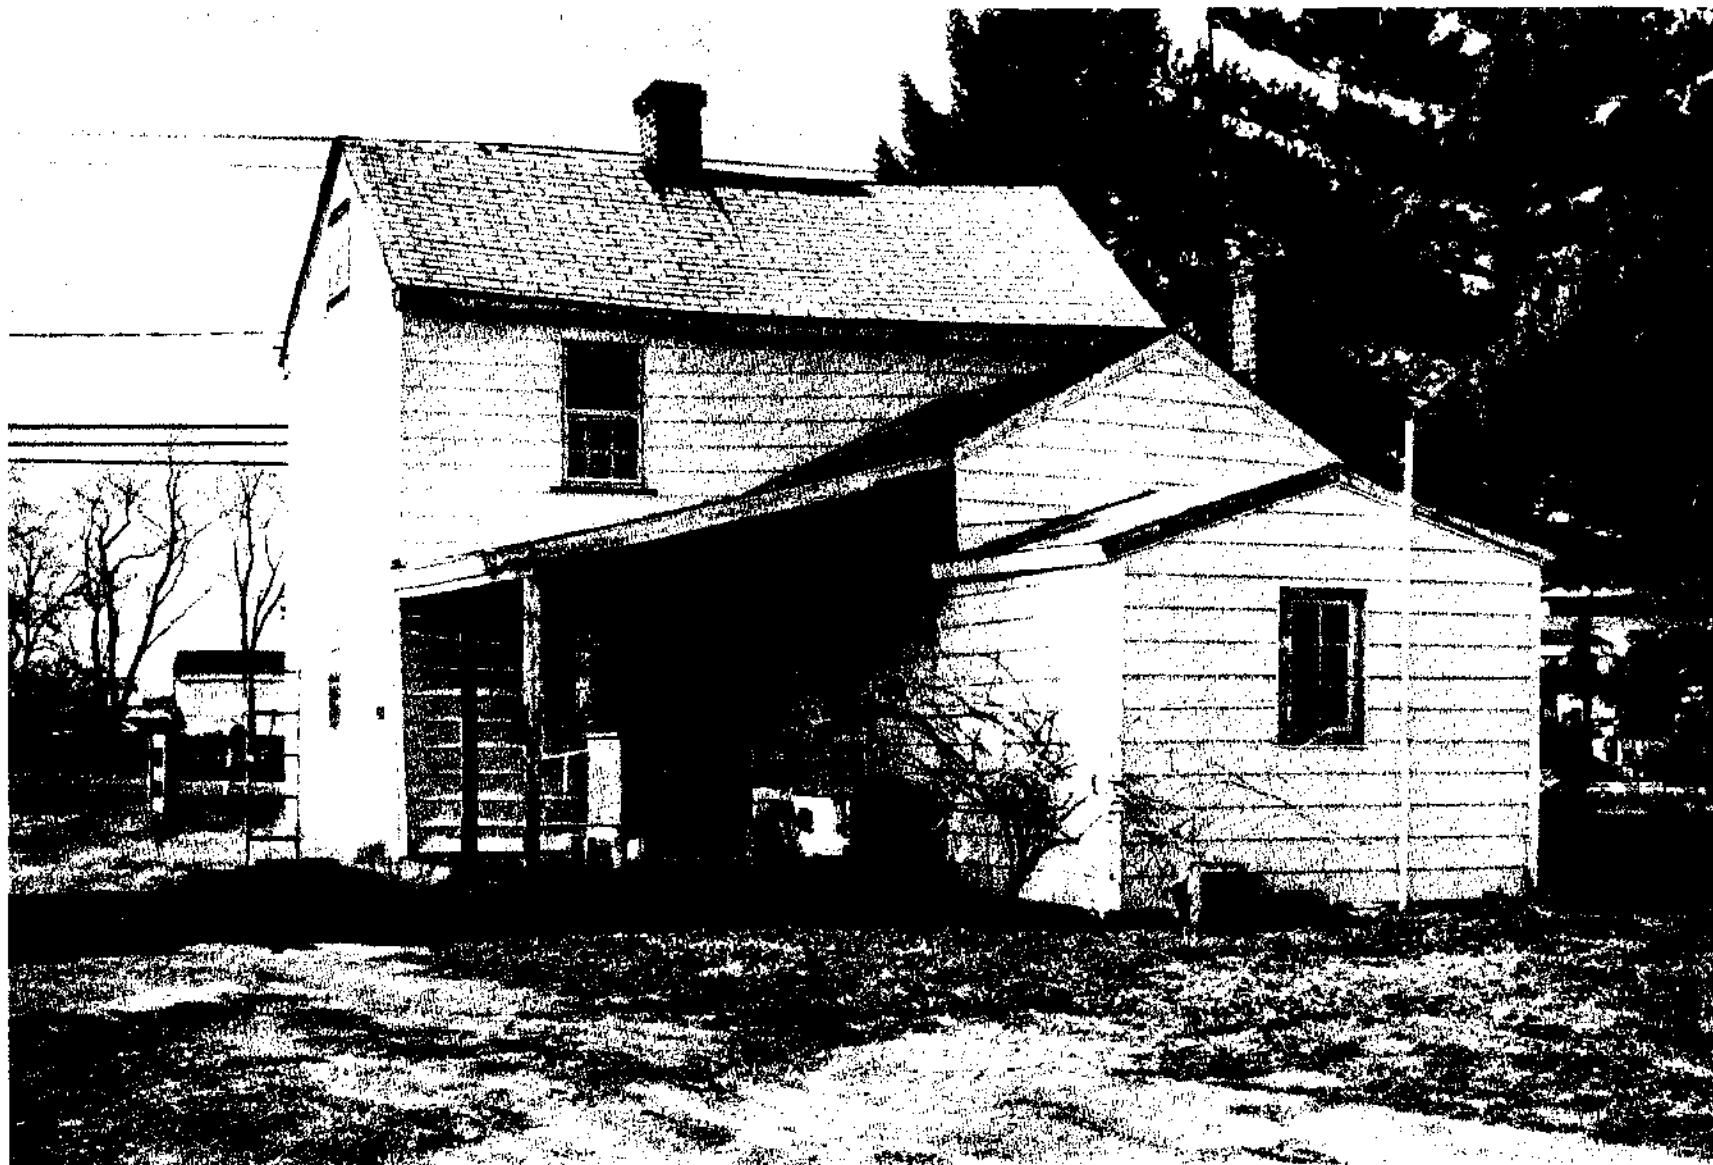
PLATE 26: Evan Lynch House, View to Northeast

The facade of the house is arranged with two windows at each story and an off-center entry sheltered beneath a metal awning. Each of the side walls has one centered first floor window and a small window for attic illumination. Most window openings are fitted with 6/6 wooden double hung sash in flat plank surrounds with drip shelves. A short brick chimney with corbelled cap is set on the main roof ridge slightly to the south of center. A second chimney is located toward the gable end of the kitchen ell. A shed-roofed porch with square wood posts and plank floor is located in the angle formed by the main block and ell. No interior information is available due to occupant's refusal to permit access.

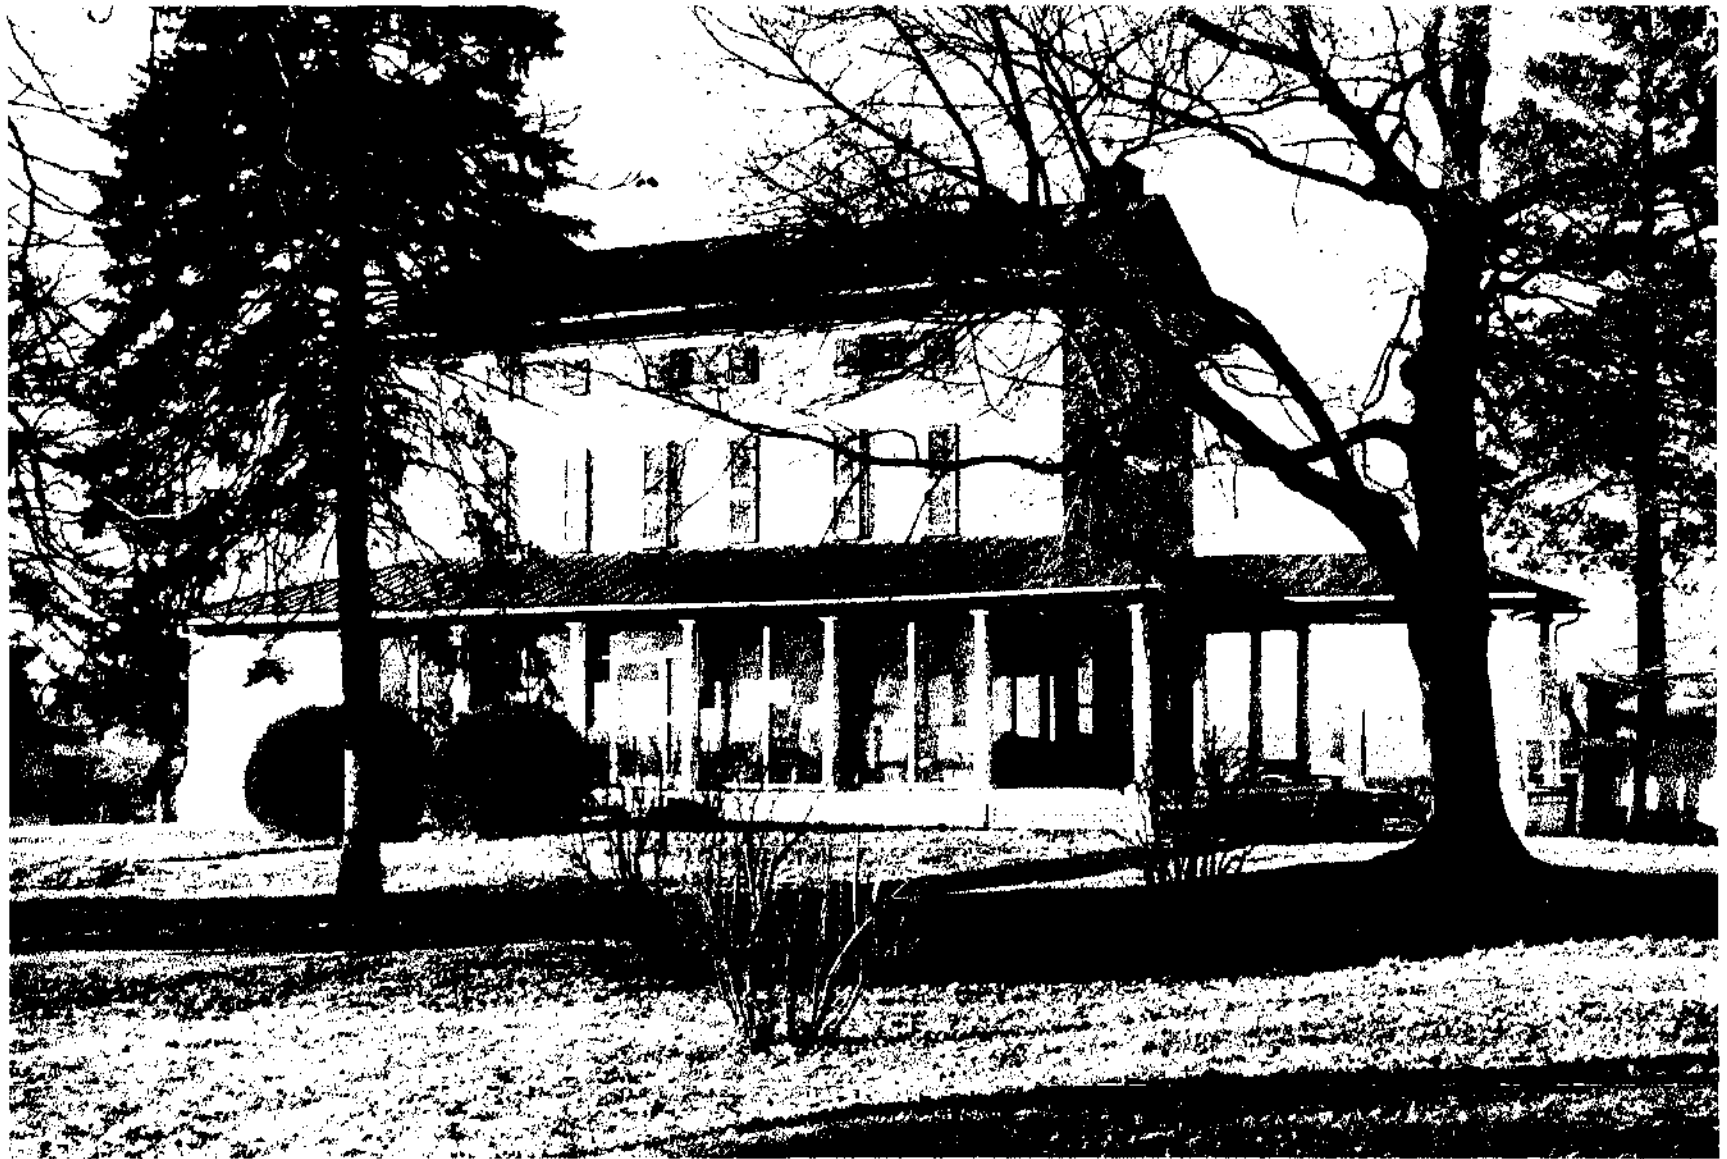
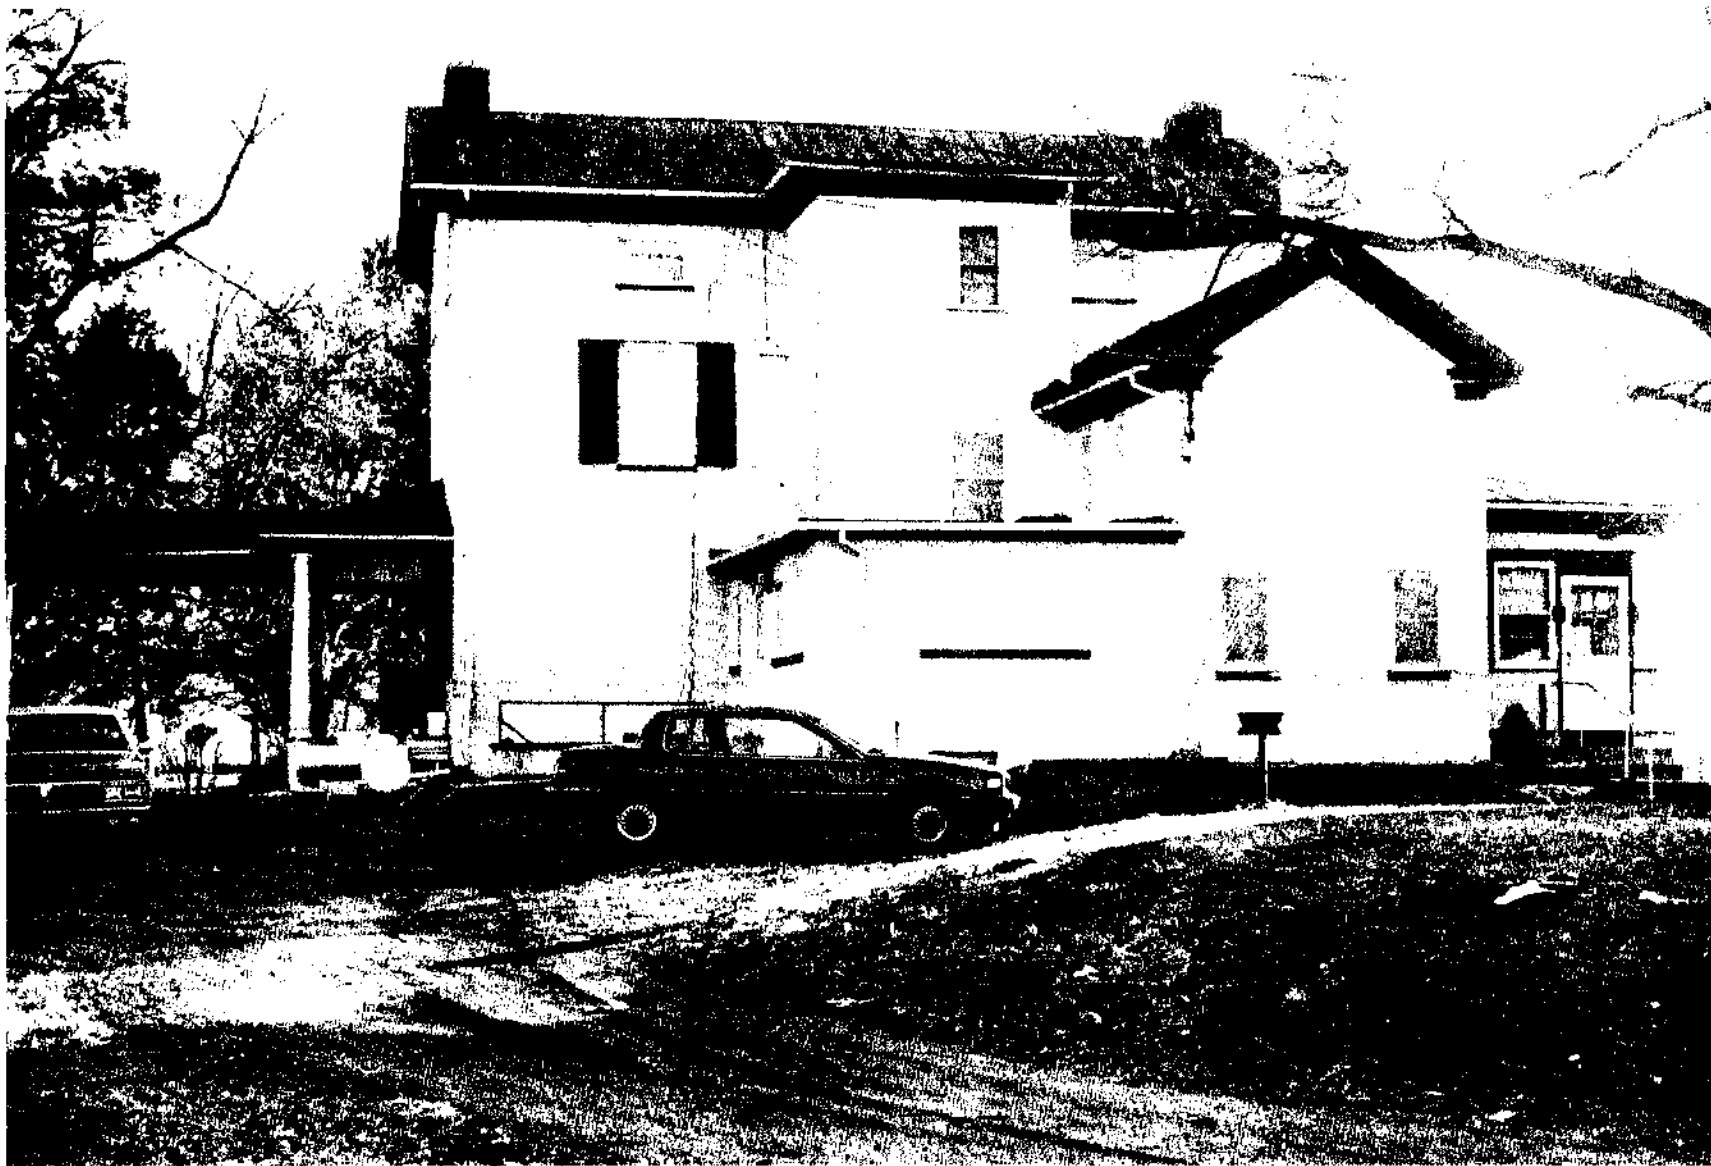
PLATE 29: The Hermitage, John Frazer House, View to Northwest

The interior of the main block is arranged according to the Georgian I-house plan, with a single room to either side of a wide stairhall. On the main floor, however, the east wall of the stairhall has been completely removed, and the brick bearing wall

on the second floor is now supported on a large boxed and paneled beam. The mantel of the fireplace on the east wall is five feet high, made of flat, unmolded wooden members and ornamented only by two stylized scroll brackets beneath the mantel shelf. The fireplace opening has been largely filled in and faced with 2" x 2" terra cotta tiles. Similar treatment has been accorded the dining room fireplace on the west gable end wall, which is smaller than that of the parlor and has a simple mantel with applied flat molding strips. Other interior woodwork found on both floors includes 6-inch molded baseboards, wide molded window and doorway surrounds with bull-eye corner blocks, and a broad open staircase with slender turned newel posts and spindle balusters (Plates 31 and 32). The attic level is fully finished as a series of small, simply-appointed rooms.

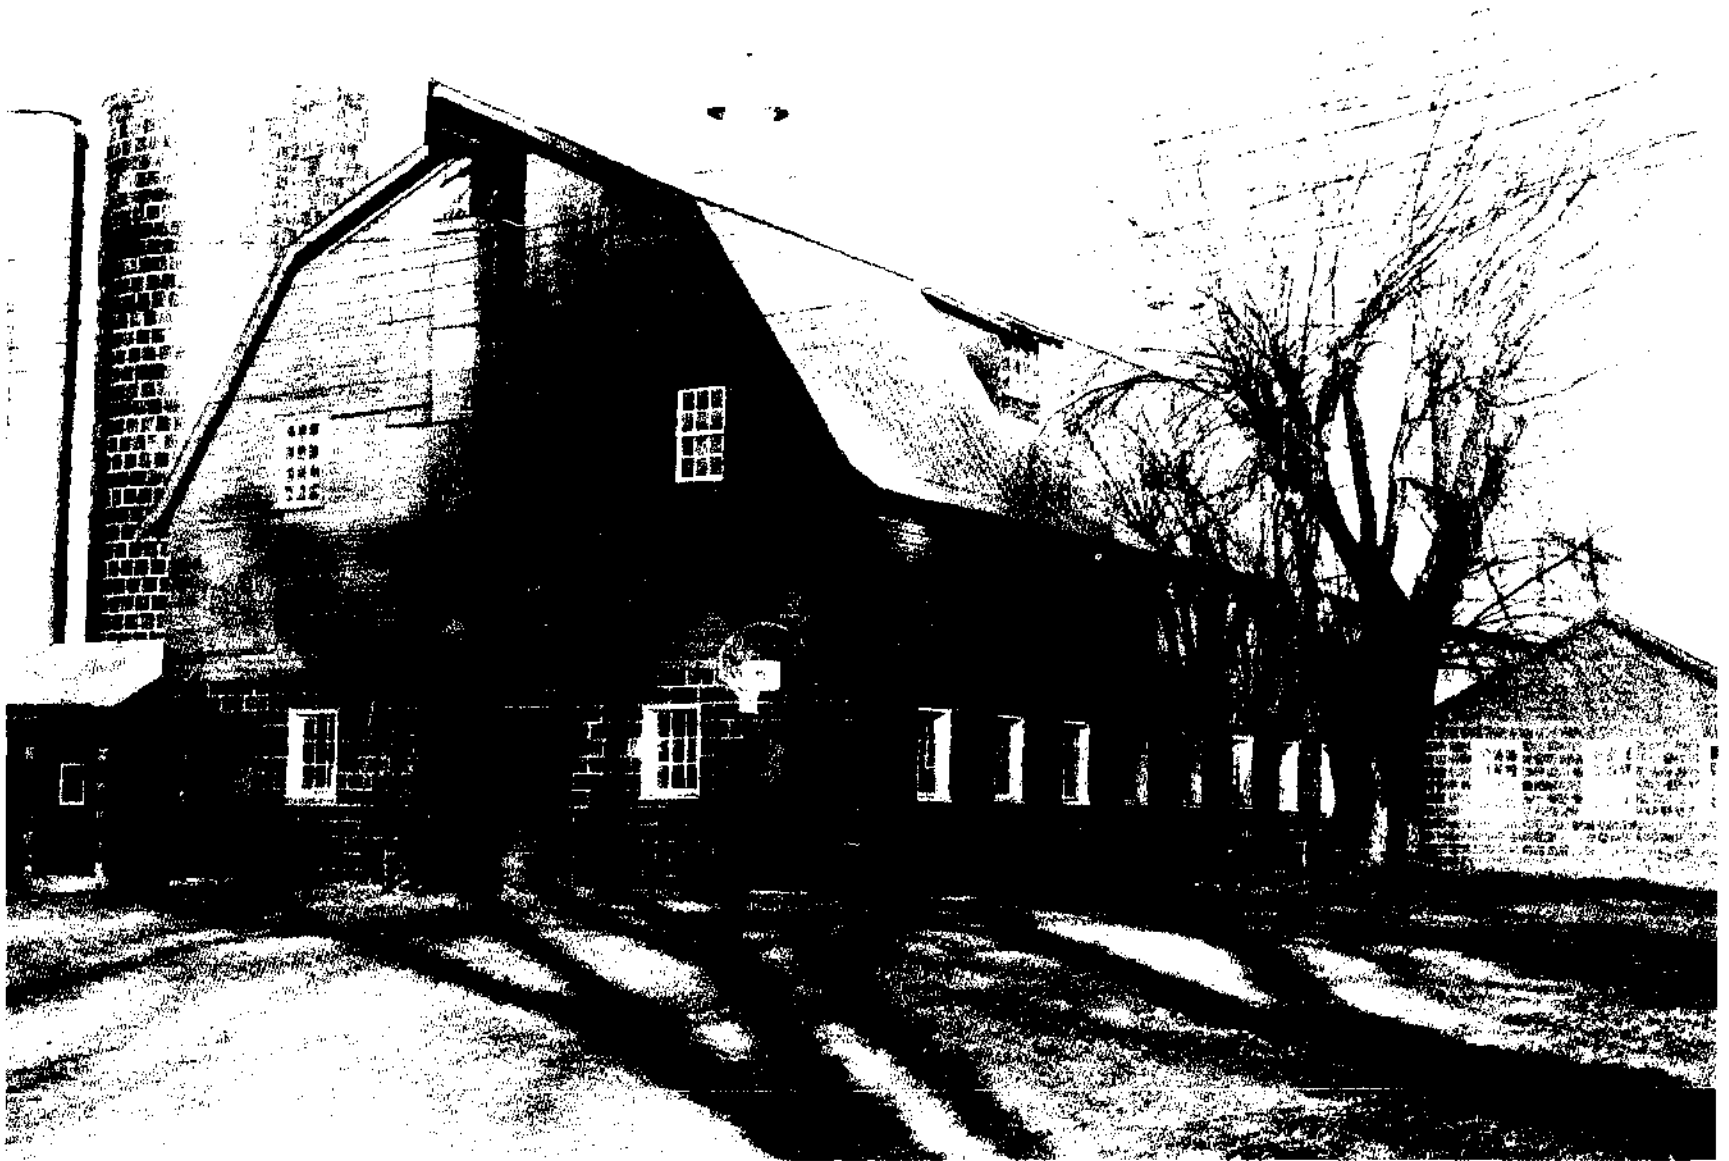
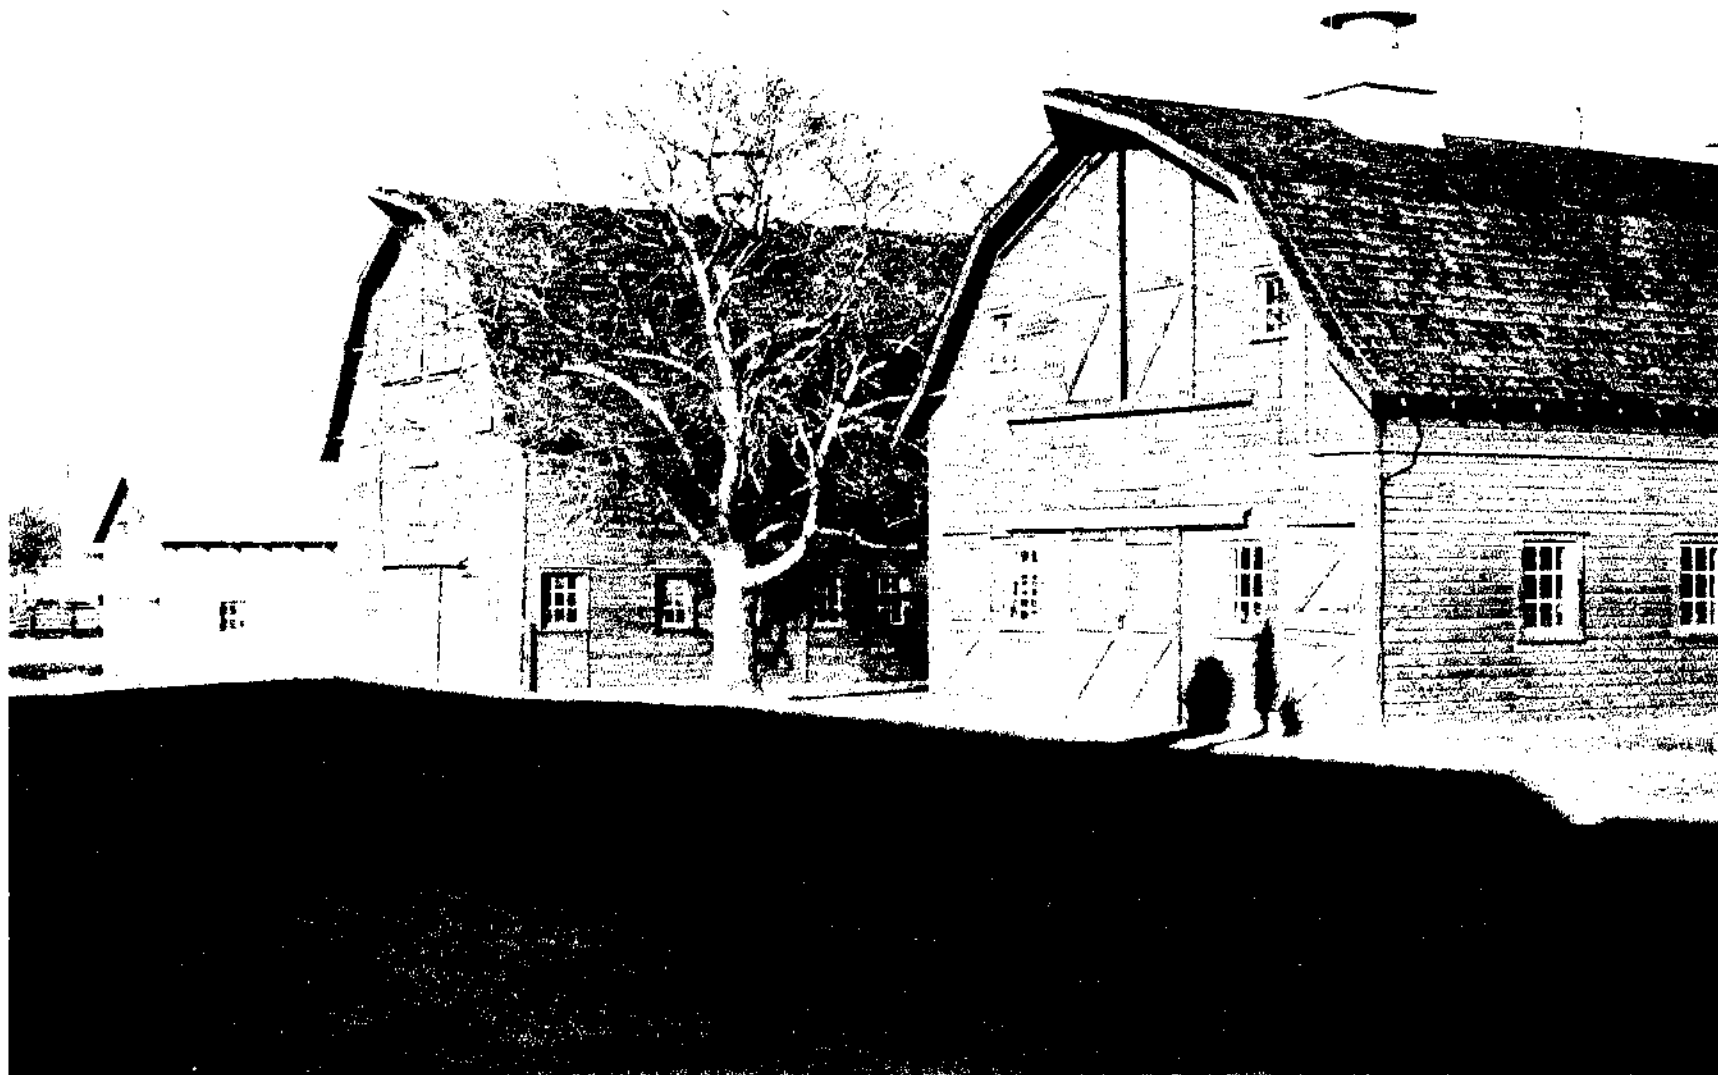
PLATE 34: The Hermitage, Main Dairy Barn, View to Northeast

maintenance and repair shop. On the east side of the lane are three gambrel-roofed dairy barns from the first quarter of this century (Plates 34 and 35). The northernmost two have wood shingle roofs, drop siding, 9-light single sash hinged at the bottom, double-leaf sliding ground floor and hayloft doors, and concrete milking floor with pipe stanchions and rows of metal columns which support I-beams carrying the lofts. The third, by far largest, dairy barn is 20 bays long, with a standing-seam gambrel roof, shed dormers, timber-framed loft level clad in drop siding, and ground level of cast concrete block, the textured outer face of which has a red-brown glaze. The same material is utilized in the two tall silos and small gable-roofed structures attached to either side of the main barn structure, the ground floor of which features a concrete floor, metal columns and I-beams, and pipe stanchions.

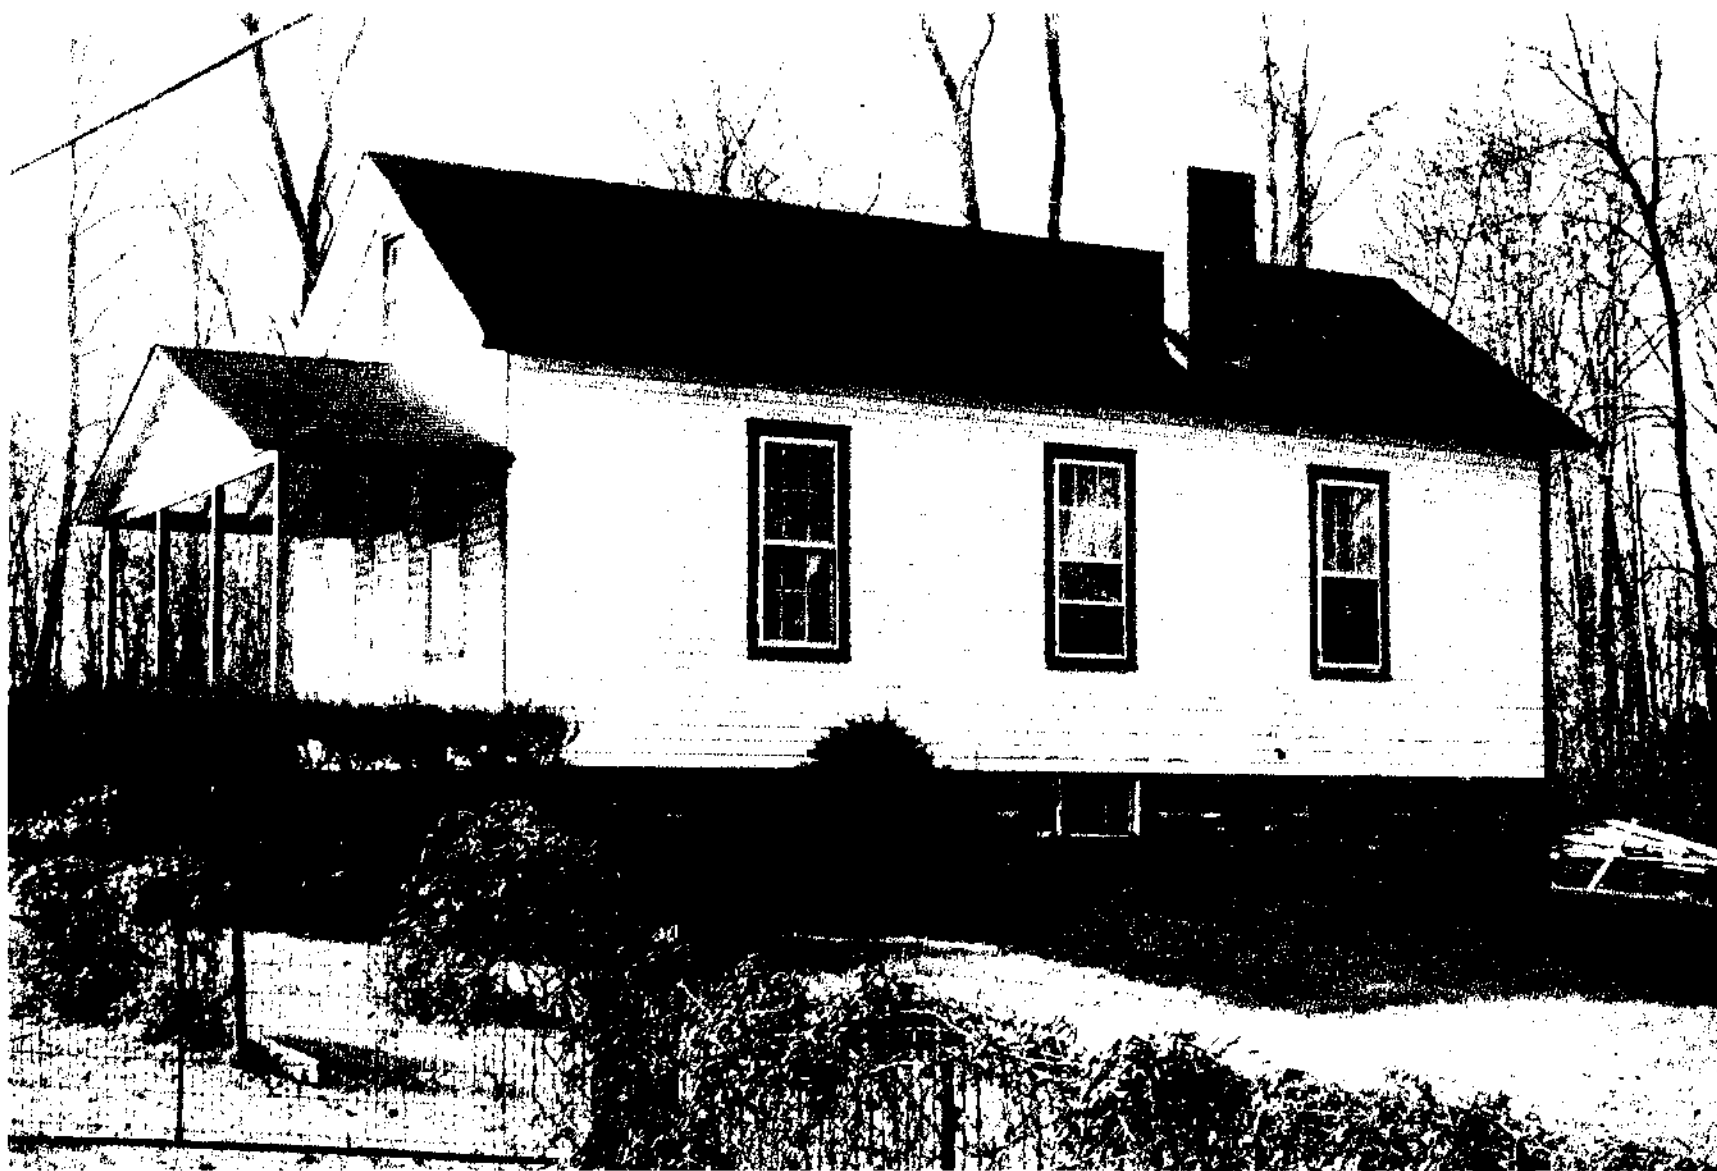
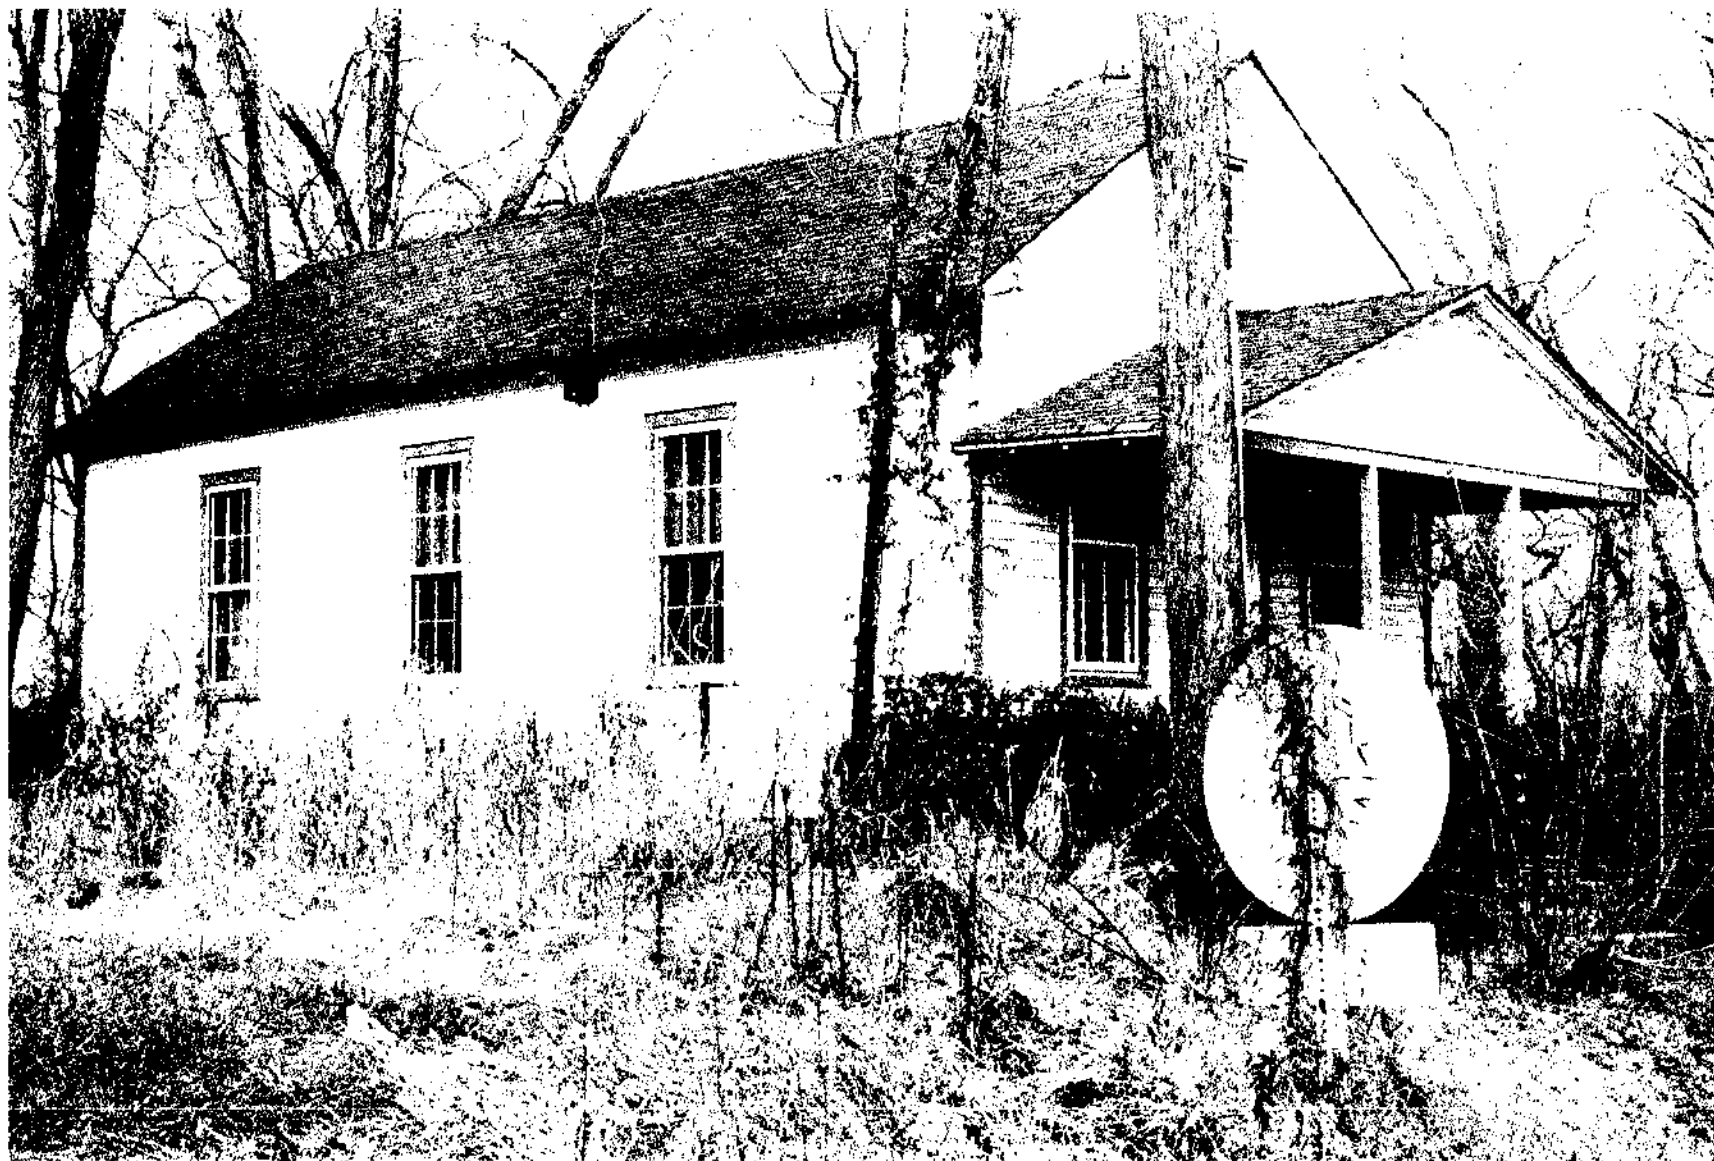
PLATE 37: School No. 56, View to Southwest

School #56 is a one-story, front-gable rectangular building of wood frame construction on a raised brick foundation encompassing a full basement (Plates 37 and 38). The exterior is clad with drop siding; the roof is covered with composition shingling and has narrow boxed eaves. The side and front elevations are each divided into three bays. Windows have flat plank surrounds with drip shelves and tall 6/6 wooden double-hung sash. The centered entrance features a six-panel wooden door above which is a large two-light transom panel. A gable-roofed porch with square posts is set on a high wood plank floor, reached by a set of concrete steps. On the north side, toward the rear, a brick chimney rises from the roof near the eave.

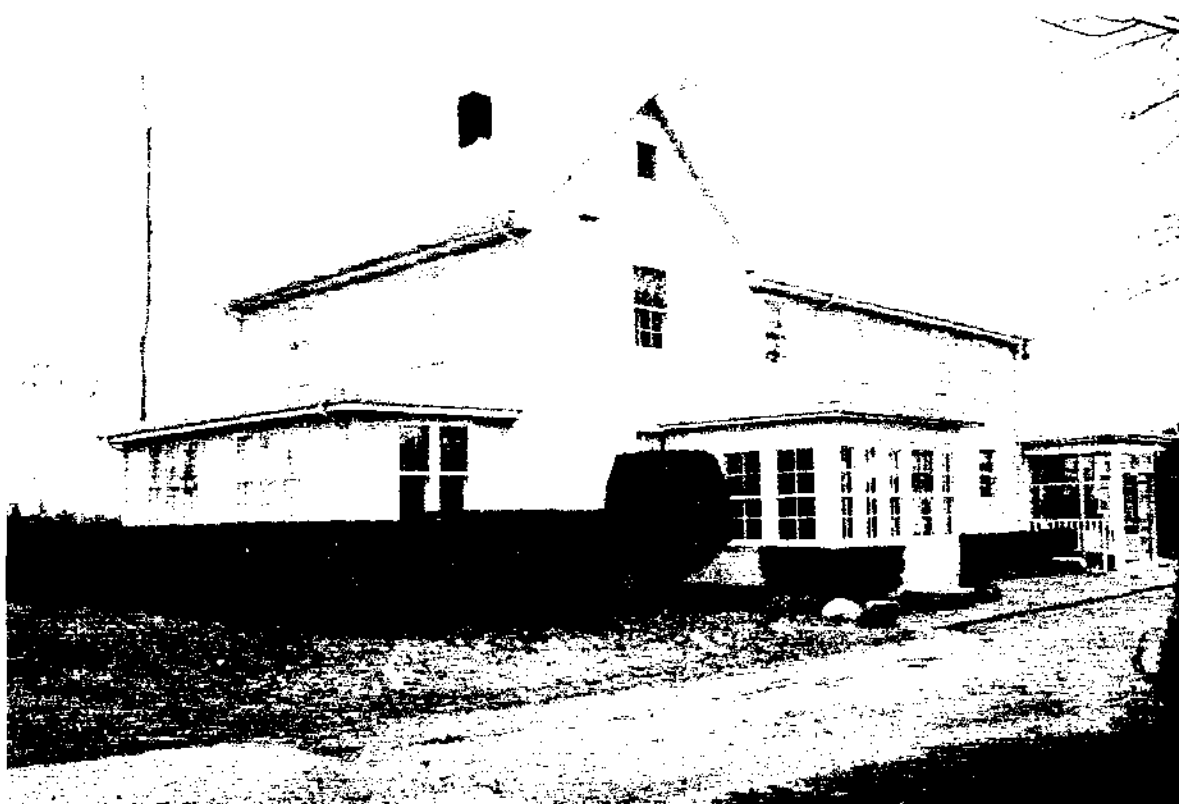
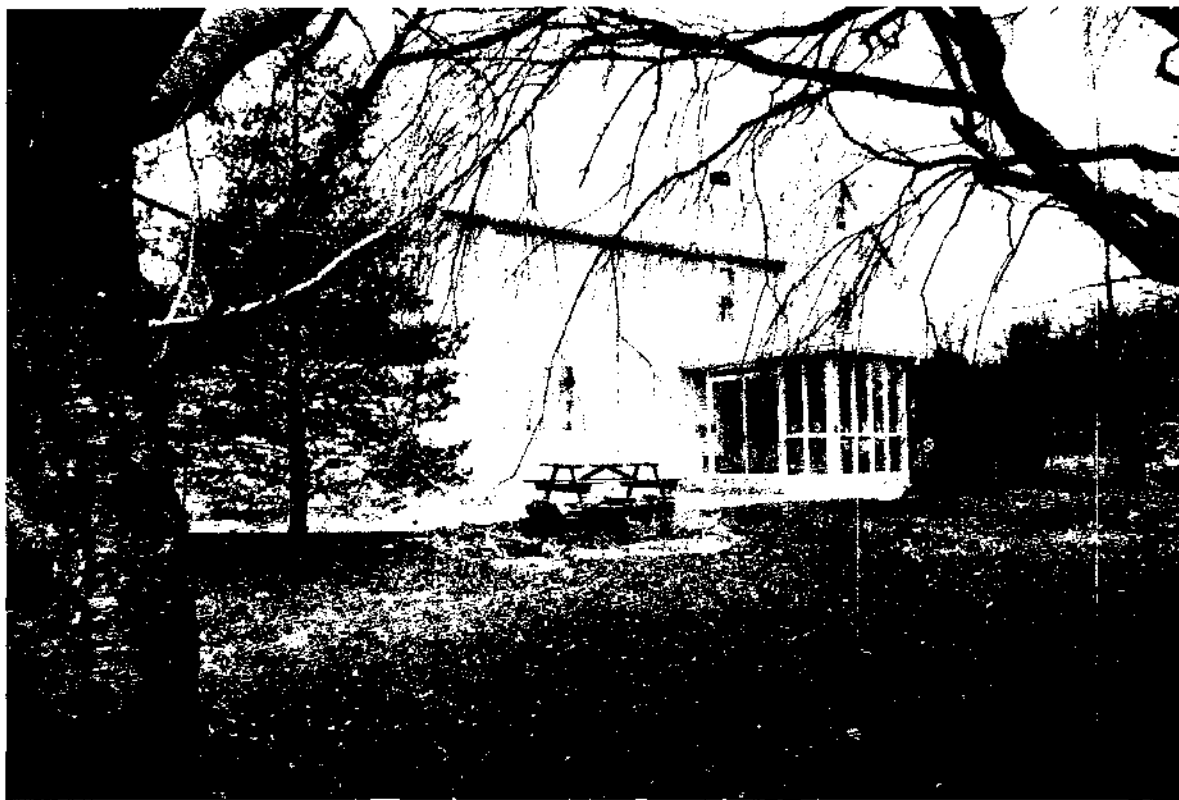
PLATE 39: Clarksdale Tenant House No 2, View Looking Northeast

Tenant House #2 (N-10616): This dwelling is situated on the east side of Route 896 adjacent to the DuPont Corporation's Glasgow plant. The dwelling is of wood frame construction, with a full basement of fieldstone beneath the front section, and is clad in blue synthetic shingling (Plates 39 and 40). According to an undated historic photo in the owners' possession, the house was originally massed as a two-story three-bay, center hall, single-pile side-gable main block with a one-story rear kitchen ell. Under the present owners, a portion of the front wall was removed, a full-length porch replaced with a fully-enclosed addition, the rear ell substantially expanded, and most of the original interior spaces rearranged. Among the few features remaining from the period prior to remodelling are several 6/6 double hung sash windows in flat surrounds with narrow drip shelves, and the brick chimney stack centered on the roof ridge.

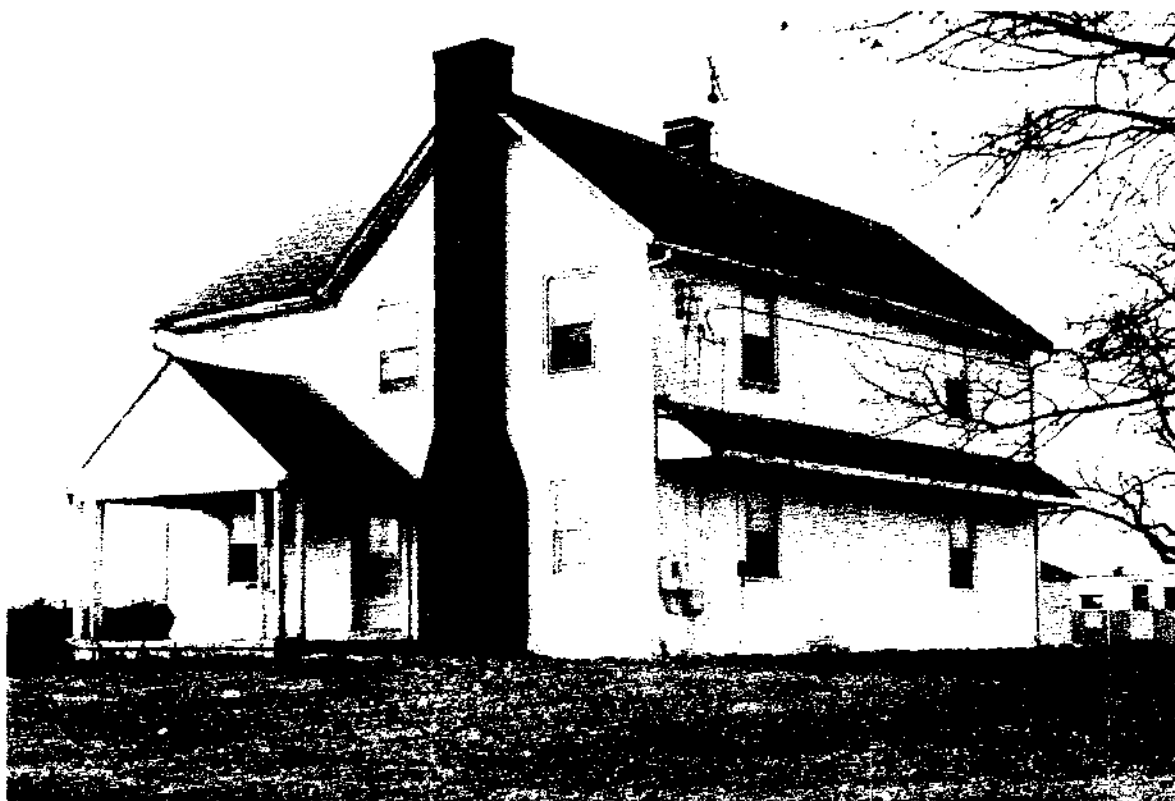
PLATE 41: Clarksdale Tenant House No 3, View Looking Southwest

Tenant House #3 (N- ): This dwelling is located some 600 feet back from the west edge of Route 896, directly opposite the entrance to the DuPont Glasgow Plant. The land on which it is located is in the process of redevelopment as the Pencader Corporate Center, and has been laid out with streets called "Corporate Boulevard" "Executive Drive", etc. Tenant residents occupy a trailer home adjacent to the house, which is vacant. The only other structure on the property is a cement block garage.

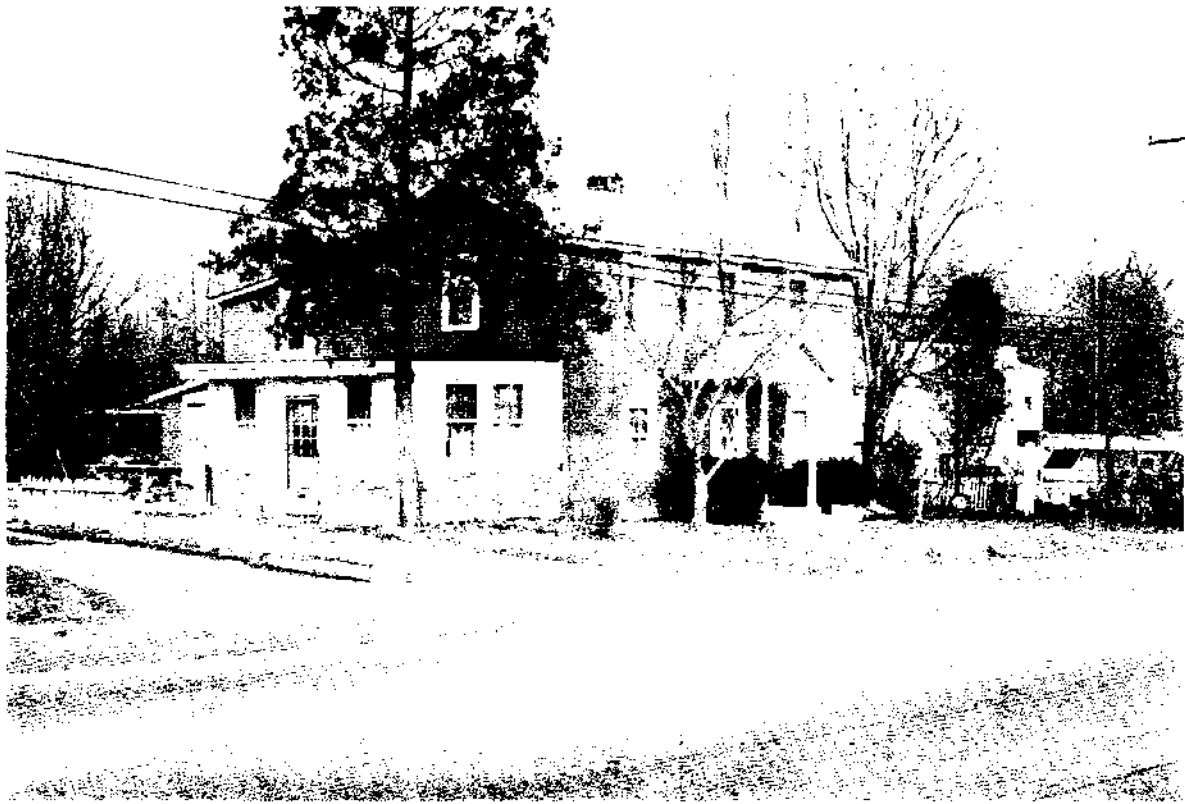
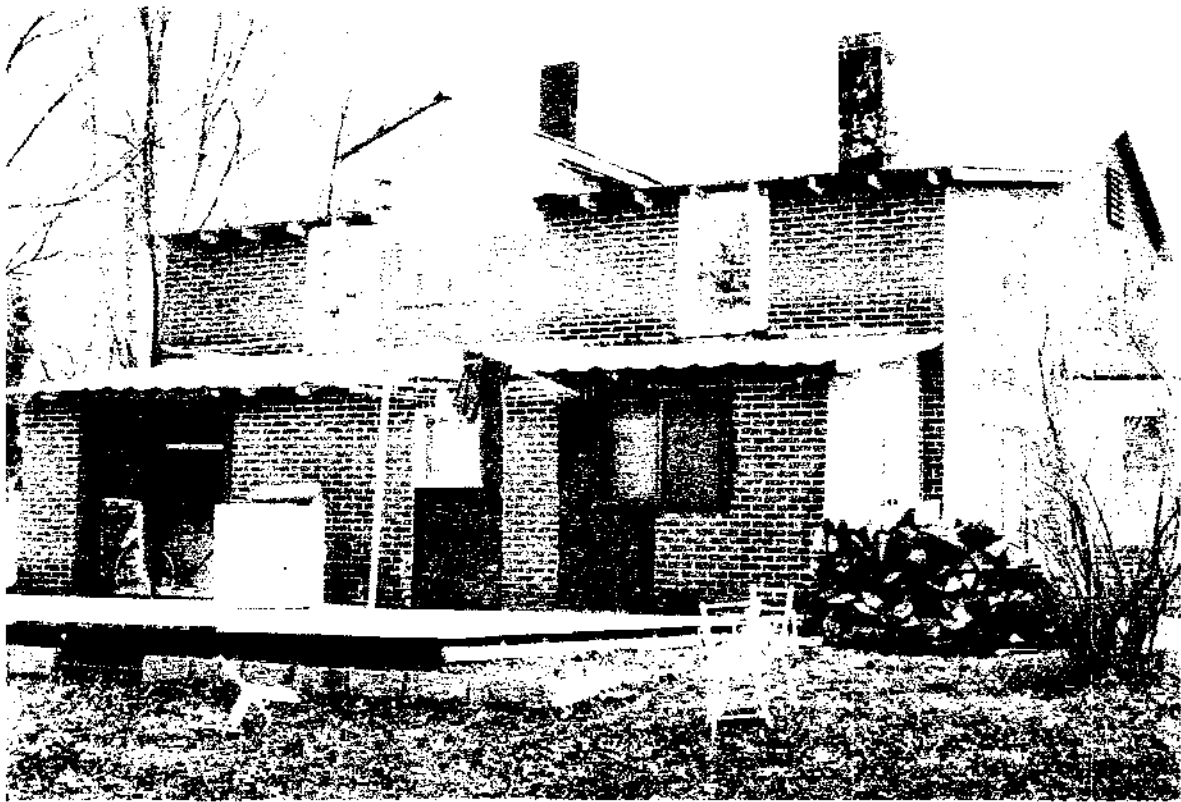
PLATE 43: Clarksdale Tenant House No 4, View Looking Northwest

Tenant House #4 (N- ): This dwelling is situated on the west side of Route 896 almost directly opposite the intersection with Road 408. The house has a two-story, side-gable single-pile

main block to which have been added two slant-roofed units, one of two stories, the other of one story, across the rear (Plates 43 and 44). The entire building, which is of wood frame construction, was covered with red facebrick in 1955, thereby completely obliterating its original exterior wall surfaces. Off the south gable end is a one-room addition on a raised brick foundation. The original main block retains most of its 6/6 double hung sash windows in flat, unmolded surrounds with narrow cornices. The eaves of the low, corrugated metal-clad roof are embellished along with the east side and gable ends with a narrow scalloped fascia board. Two tall brick interior chimneys are symmetrically located on the rear roof slope. A one-bay porch with standing-steam metal clad gable roof and thin Tuscan Doric style columns shelters the main entrance.
